COMPANY PRESENTATION AND FENDER DESIGN FAILURES

18th Intermodal Africa, Alvaro Rodero 21th-23th November 2017

PART 2: FENDER DESIGNS FAILURES

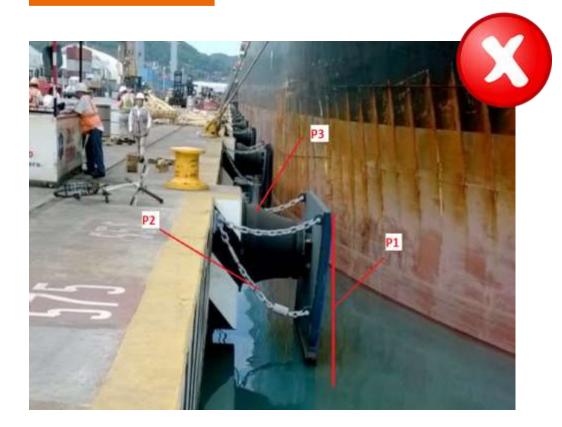
Incorrect solution by low cost supplier

- P1 Unfavorable panel position. Rubber fender installed too close to the top edge of the panel. Deflection by dead weight. "Propeller" Fender System.
- P2 Chains with the incorrect angle and length not protecting the fender rubber unit, even normal tension/weight/shear loads.
- ▶ P3 Low rubber quality. Incorrect Design. Rubber fender is "sagging.

- High peak hull pressure onto vessels' hull.
- Potential damage to the vessels' hull.
- Panel self weight supported by rubber instead by the chains.
- Torsion and bending loads damaging the rubber unit
- Cracks and damages in the rubber.
- Lower fender performance
- Reduction of life cycle of the system.
- Increase in maintenance and replacement costs
- Additional losses for stopping operations during replacement/maintenance.

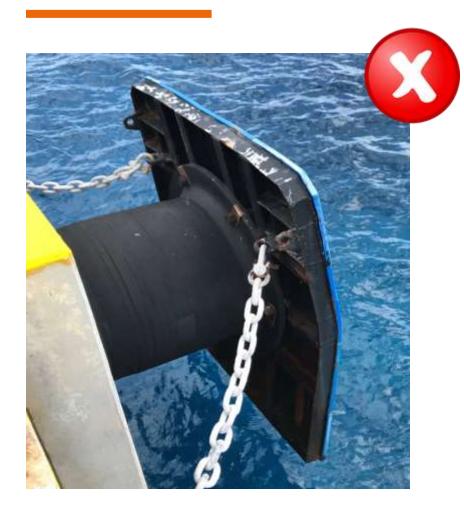
Incorrect solution by low cost supplier

- Panel internal structure under sized.
- Wrong structural calculation.
- Thickness of the steel beams is lower than required for the applicable load cases.

- Bent Panel.
- Increase of hull pressure onto vessels.
- Dramatic reduction of the life cycle of the systems.
- Increase in maintenance and replacement costs.
- Additional losses for stopping operations during replacement/maintenance.

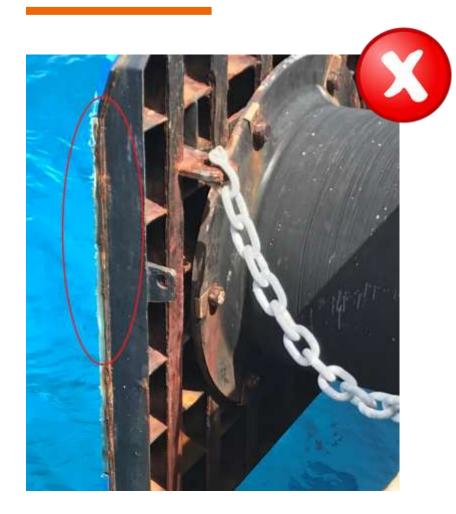
Incorrect solution by low cost supplier

- Use of not appropriate FQ /100% virgin material with high molecular weight
- Material used has reduced molecular weight
- Material used has a high abrasion index

- Quick deterioration of protection pad
- Damages into the steel panel
- Increase on shear forces Damage to the rubber unit
- Reduction of the life cycle of the fender system
- Increase in maintenance and replacement costs
- Additional money losses for the stop in operations during replacement/maintenance

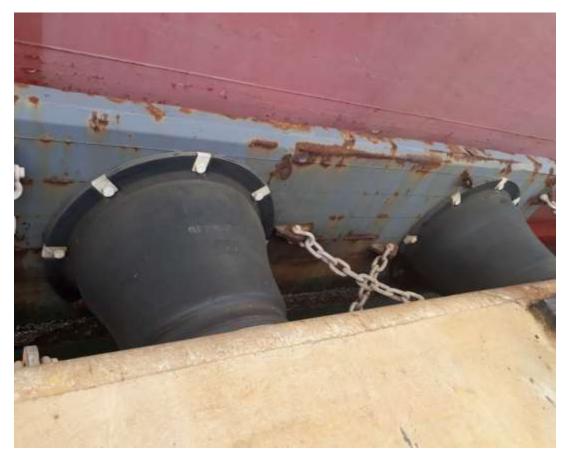
Incorrect solution by low cost supplier

- Coating system for the panel not suitable for marine environments
- Coating system for the panel below the required minimum thickness
- Hardware not hot-dip-galvanized/stainless steel
- Other corrosion protections such us zinc anodes not used.

- Deterioration of steel components
- Thickness reduction on the steel plates
- Reduction on the steel panel load support capacity
- Damages on anchors and chains
- Dramatic reduction of the system life cycle
- Increase in maintenance and replacement costs
- Additional losses for stopping operations during replacement/maintenance
